Market/Greene Alternative (Preferred Alternative) Limited Initial Site Assessment, Aluminum Recycling Corporation
Figure 4-44

Market/Greene Alternative (Preferred Alternative) Limited Initial Site Assessment, BNRR- Hillyard Property Sequence No. 991 (Former RR Yard)
Figure 4-45

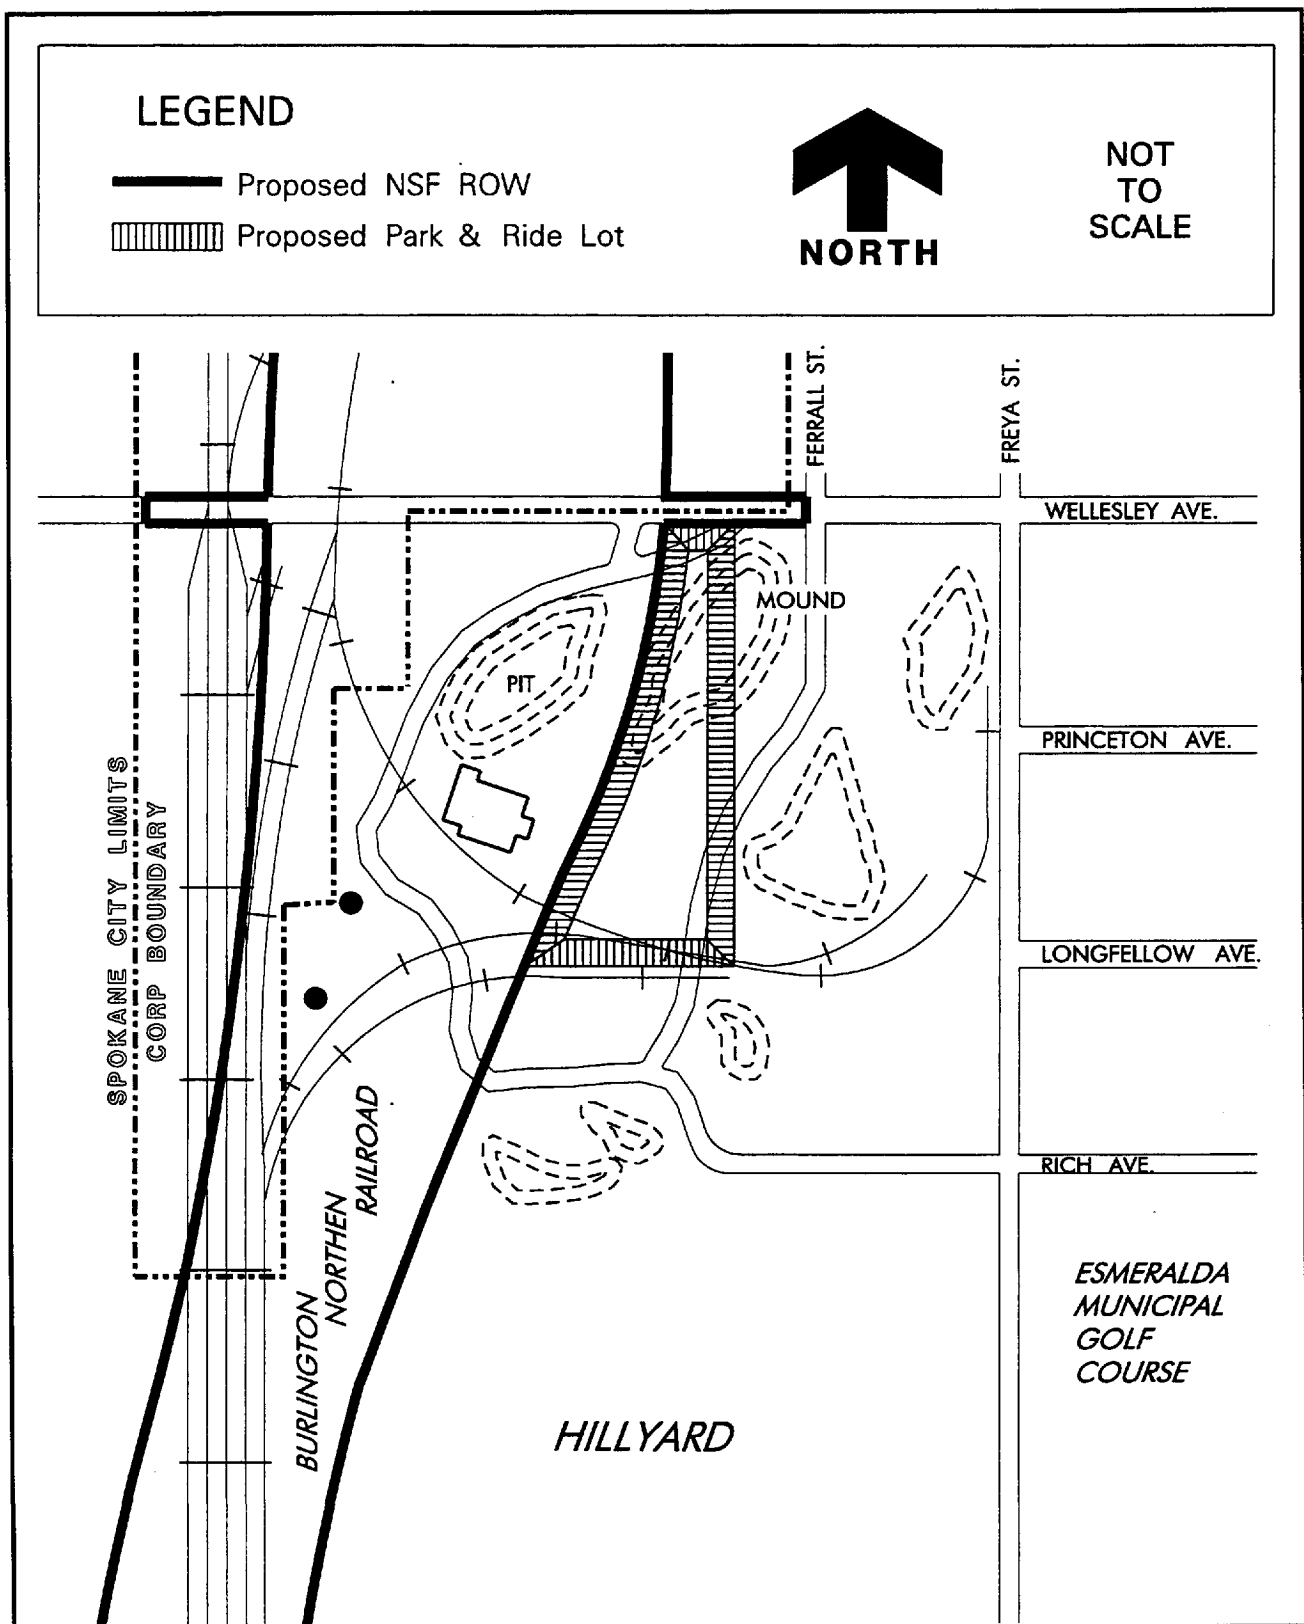
Aluminum Recycling is a closed secondary aluminum smelter, where aluminum was reclaimed/recycled from scrap metal, beverage cans, aluminum oxides, and aluminum furnace skimmings (dross). The facility has been inactive since the mid 1980s. Waste piles of black dross (sodium and potassium salts, as well as the possibility of recoverable aluminum) are present on site, both above grade and in pits (see **Figure 4-44**). There is several thousand cubic meters (yards) present at this location. Suspected hazardous substances associated with the site include sodium salts, potassium salts, aluminum, copper, ammonium nitrides, potassium aluminum fluoride and ammonia.

The WDOE C&SCS list indicates the site has confirmed soil contamination. The Affected Media Report stated “the site has confirmed soil and potential ground water, drinking water, and air contamination.” The C&SCS report further indicates the site is effected by metals (non-priority) and conventional and inorganic

Additional notes in the site WDOE Hazardous Waste and Toxics Reduction File indicate the site was stabilized with Monolac, which is similar to Elmer's glue, in 1989 as a response to the fugitive dust emissions. Minor amounts of ammonia gas are released when 'fresh' dross is exposed to water; thus, special provisions will need to be taken when the dross is moved or disposed.

As shown in Appendices D, page D-8, construction on this site will also involve a "park and ride" site. Discussions with WDOE led to the belief that, should it be agreed to by all concerned parties, the paving of this site, in conjunction with stormwater controls, could serve as an 'Institutional Control' for the contamination problem. This would allow the contamination to be left in place. Should this option work as the control, the main concern would be fugitive dust during the movement of the dross. If this control does not work, another possible solution would involve determining if agronomic land application would be appropriate as suggested by WA. Dept. of Natural Resources. Disposal into an authorized landfill would be the final option (See Figure 4-44).

Engineering estimates are 52,000 m³ (68,000 yd³) of affected material on this site. Using \$89.00 per m³ (\$68.00 per yd³), the estimated disposal cost total is \$4,700,000. Fugitive dust control during this cleanup will also be required, which adds another estimated \$15,000. The estimated cleanup costs for this site total \$4,715,000. This cost assumes that the material must be disposed of in an approved site. WSDOT is hopeful that one of the less costly options will prevail.

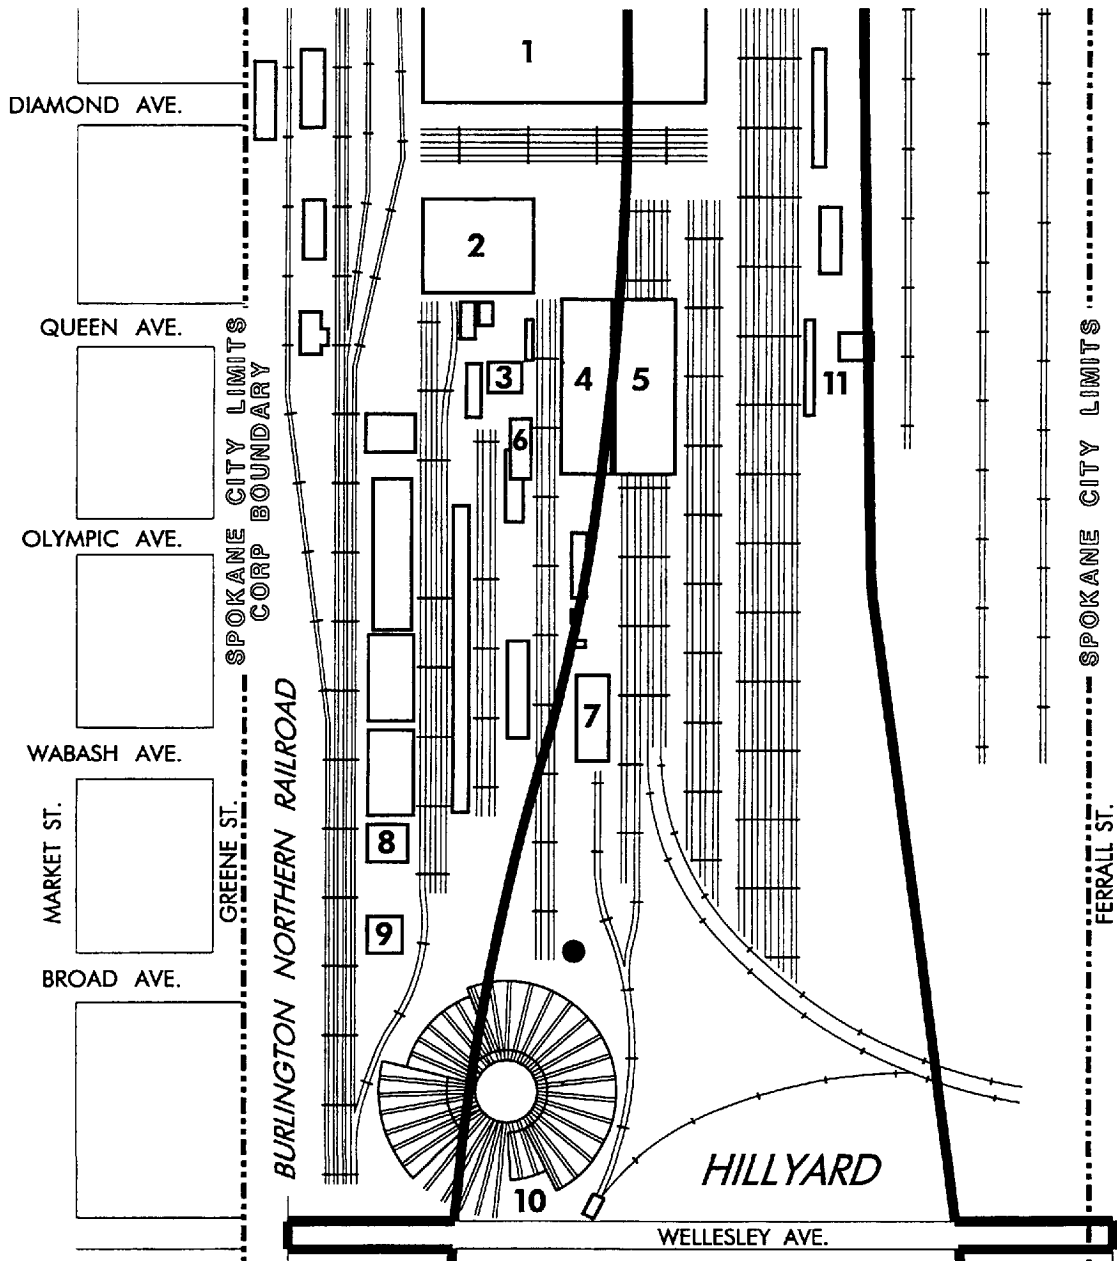
The BNR Hillyard Yard (property sequence No. 991) is listed on the C&SCS Report as having soil affected by petroleum products. A pit lined with timbers was found to contain waste oil. The theory is that steam cleaning contaminates drained into this pit. Independent remedial action has been conducted and an Interim Remedial Action Report was received by WDOE. The Hazardous Sites List

There has been recent dirt movement on this property and there are also many areas void of vegetation. Soil surfaces in the area appear to be mixed with a purple substance. Illegal dumping has taken place within the property boundaries. Soils, presumably contaminated, appear to have been placed on cement concrete pads which run the length of the property to bioremediate. Additional soils in the area have been tilled for unknown reasons. Discussions with a consultant that worked on the property in the mid 1980s indicated that a hand dug well, 18.3 to 21.3 meters (60 to 70 feet) due north of the water tower, remains on site and is covered with timbers and partially filled.

As identified in the previous text and the following site map, this property sequence has numerous identified potential 'hot spots'. Although some of these hot spots have been remediated, there is very little record of most of the others. Several different site maps confirm the locations of these hot spots. Some of the westerly locations will not affect the proposed alignment and the southern turntable has been removed. Reviewing the history of the railroad functions that are shown on **Figure 4-45** leads to the conclusion that those soils needing remedial action will require some type of a disposal option. These areas, other than the plumbing network, should be localized in their limits.

The area for each portion of this site, noted on **Figure 4-45**, was measured and the contamination estimated to a depth of 9.14 meters (30 feet). Engineering estimates for this suspect contaminated soil totals 56,900 (74,400 yd³). Again using the figure of \$110.00 (\$83.00 yd³) for disposal, the soil total is \$6,257,500. Adding another \$100,000 for remediating the asbestos, brings the total cleanup estimate for this site to \$6,357,500

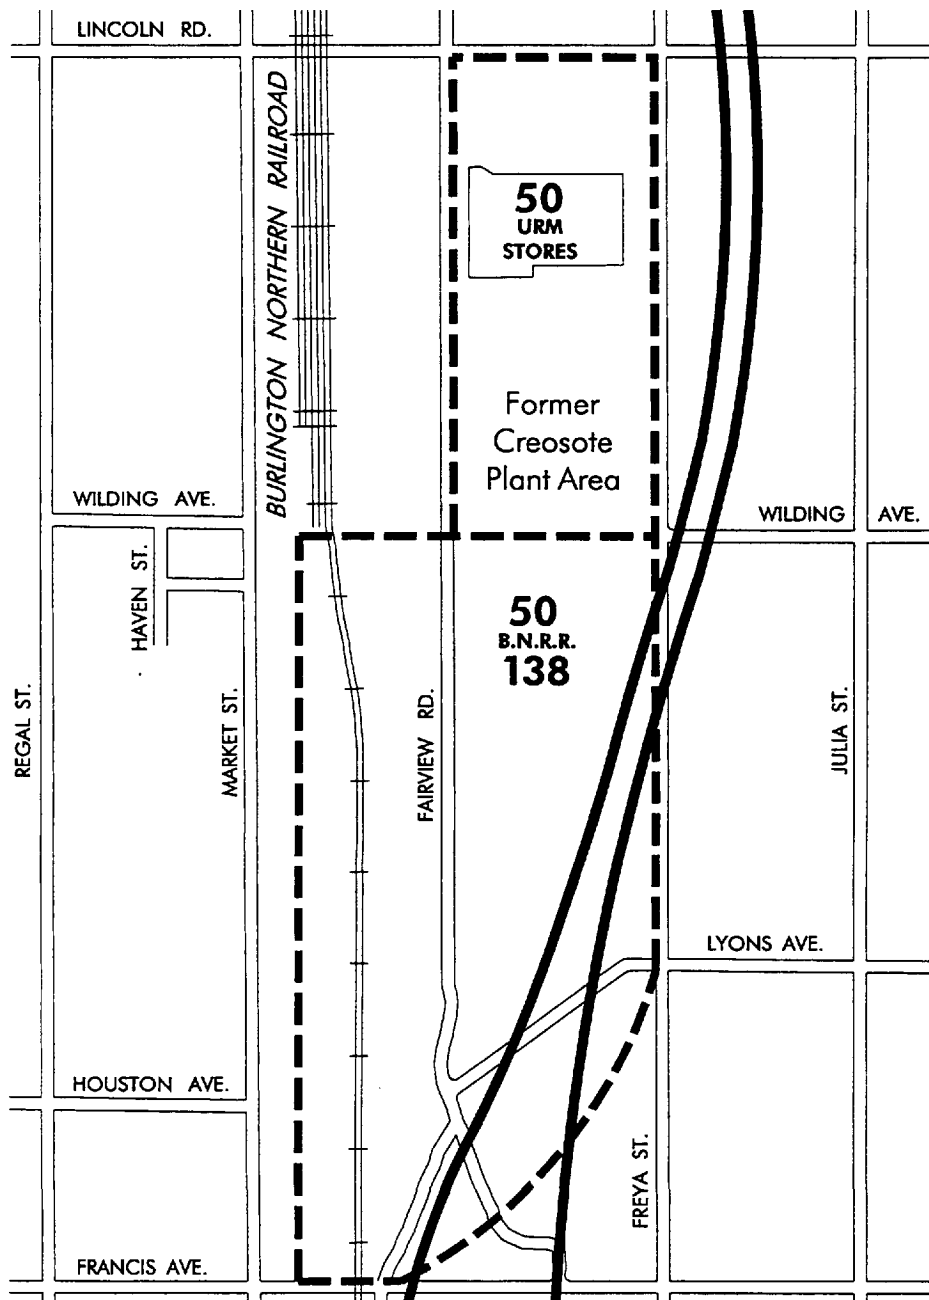
Market/Greene Alternative (Preferred Alternative) Limited Initial Site Assessment, URM Stores and BNRR Property Sequence No. 138
Figure 4-46

The URM property is west and immediately adjacent to the proposed route. The property was formerly part of the BNR Property Sequence No. 138 and significant amounts of contamination have been discovered on site (see **Figure 4-46**). The URM property and Property Sequence No. 138 will be discussed simultaneously in this section.

In 1992 during an expansion project, URM encountered the covered sumps. URM and BNR are conducting an independent site cleanup. Chemical analysis has indicated the presence of petroleum hydrocarbons, metals, and semi-volatile organic compounds. Approximately 27,500 cubic meters (36,000 cubic yards) of soil were removed in October and November 1992. This soil was separated into contaminated (14,500 cubic meters (19,000 cubic yards)) and non contaminated stockpiles (13,000 (17,000 cubic yards)) based on field screening results. Due to the presence of PAH compounds, the contaminated soil stockpile was designated as a state-only dangerous waste.

The only confirmed contamination information on this property sequence addressed that portion identified as the new (1992) southern URM Warehouse Building. This area contains contaminated soil associated with a previous wood treatment (creosote) operation. Much of the contaminated soil from this operation has been removed and stockpiled on site, awaiting disposal. As indicated by the preceding

text and the following site map, the proposed alignment will avoid the site (see also Appendices D pg. D-10). The potential hazard is that the limits of the overall contamination were not defined. The potential does exist that isolated lenses of the contaminated soil may extend to the east of this parcel.

Engineering estimates figured 6,000 m³ (7,800 yd³) of contaminated soils would be encountered. Using the \$89.00 per m³ (\$68.00 per yd³) disposal figure for this quantity, the total estimated cleanup cost for this site is \$534,000. 3225 Lincoln Street - North Market Street Superfund Site

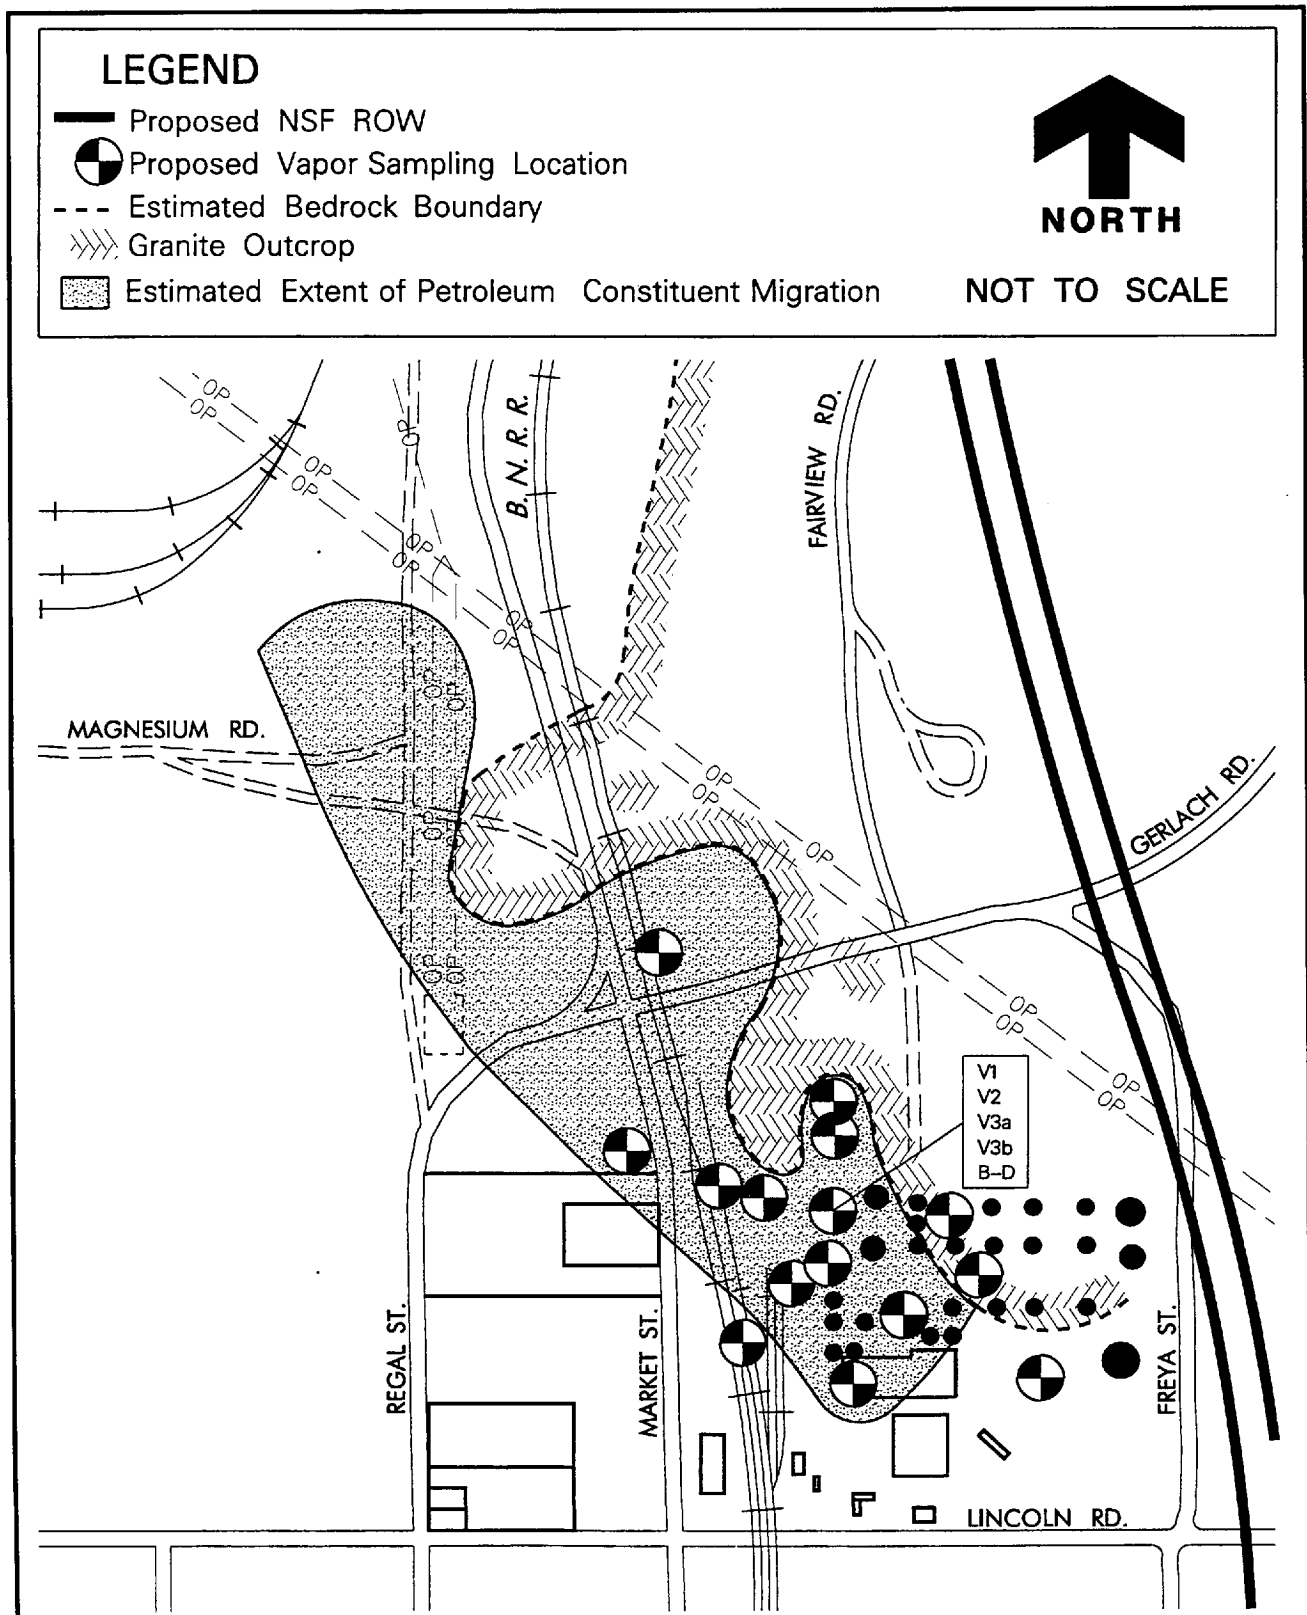
Market/Greene Alternative (Preferred Alternative) Limited Initial Site Assessment North Market Superfund Site
Figure 4-47

The C&SCS list indicates confirmed contamination, including; halogenated organic compounds, petroleum products, non-halogenated solvents, poly-nuclear aromatic hydrocarbons, and base/neutral organics in the soil.

The proposed right-of-way take associated with this property just touches the northeast corner of the North Market Street Site. The property take will be for the re-alignment of Freya Street (See Appendices D pg. D-11). As shown on the following site map, the well studied and documented North Market Street Site does not show contamination on this portion of the property; however, in a recent drive-through, it appeared that ‘soil farming’ was taking place on this portion of the property. If cleanup is necessary on this property, it should be very minimal.

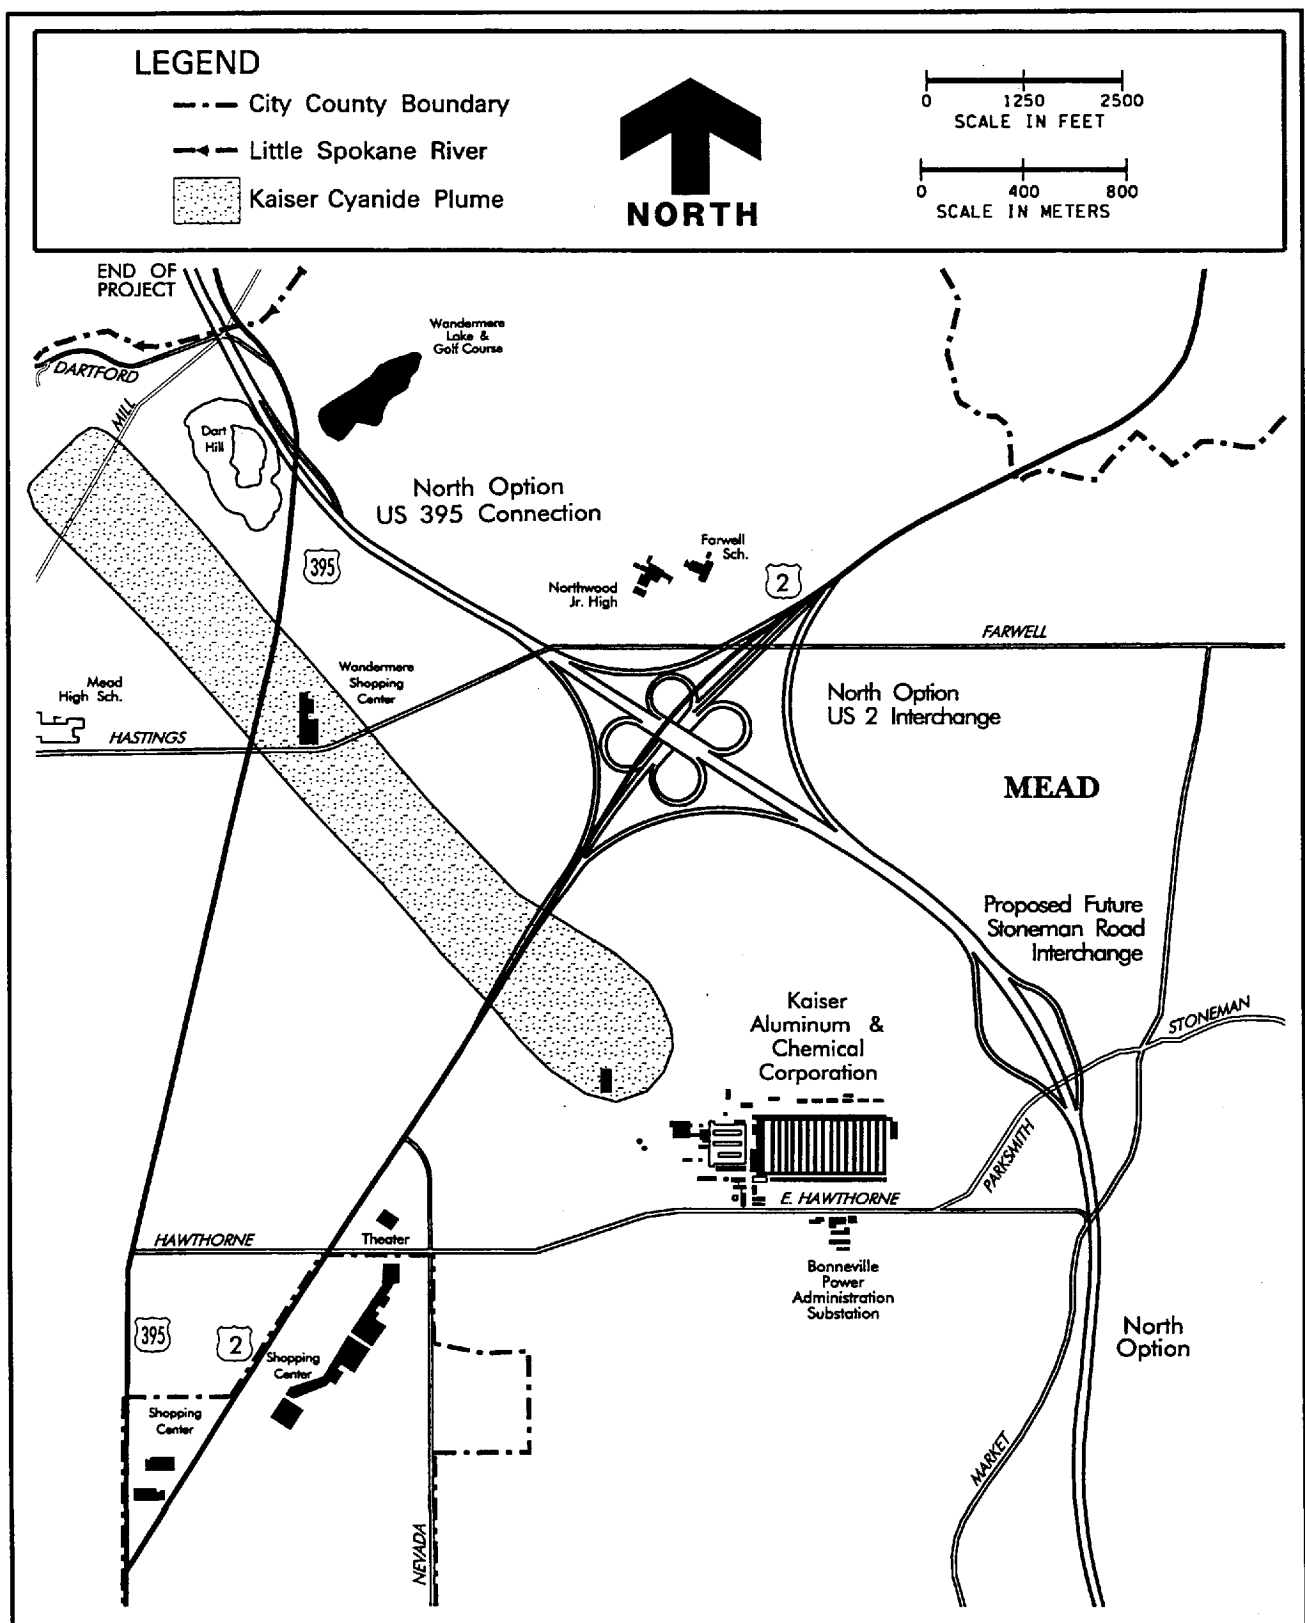
Market/Greene Alternative (Preferred Alternative) Kaiser Cyanide Plume
Figure 4-48

The Kaiser Aluminum Cyanide Plume has affected the Spokane Aquifer around the aluminum facility and in a north and northwesterly direction, flowing away from the plant to the Little Spokane River. The Cyanide Plume is to the west of the North Option; therefore, construction is not likely to encounter the contamination associated with it (see **Figure 4-48**). Groundwater mounding will need to be modeled to determine whether stormwater, when concentrated into filtration areas, will affect the flow patterns of the Plume. Mounding from stormwater may divert the Cyanide Plume and contaminate additional public water supplies.

The proposed alignment of the North Alternative is to the north of, and parallel to, the Kaiser Cyanide Plume. The plume does not affect the route.
